Manhole Inspection Summary

Manhole # S39C__033MH

Insp Date: **11/5/08 2:35 PM**

Location Address: **1099 orleans st**

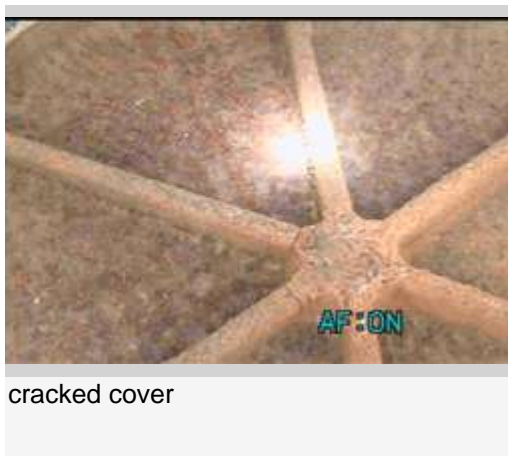
Defect 4

Condition: **Cracked**

cracked cover

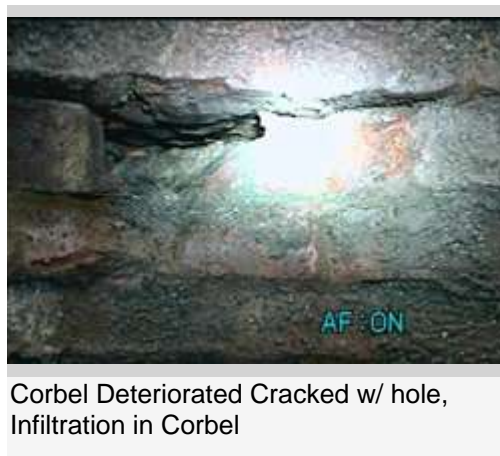
Defect 3

Condition: ☐ Sound ☒ **Cracked** ☐ Root Intrusion ☒ **Loose Brick** ☒ **Deteriorated**

Infiltration: ☐ None ☐ Joint ☒ **Cracks** ☐ Mortar ☐ Roots ☐ Wall

Corbel Deteriorated Cracked w/ hole,
Infiltration in Corbel

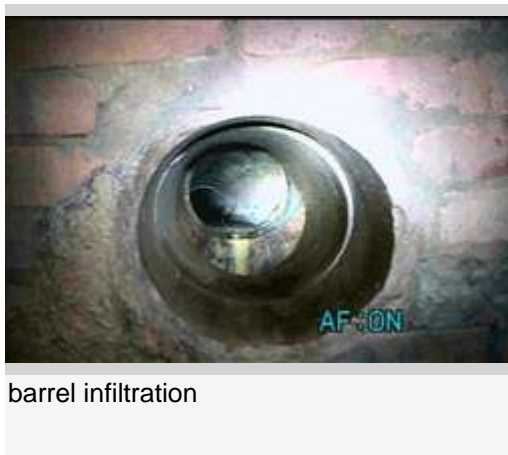
Defect

Infiltration: ☐ None ☐ Joint ☐ Cracks ☐ Mortar ☐ Roots ☒ **Wall**

barrel infiltration

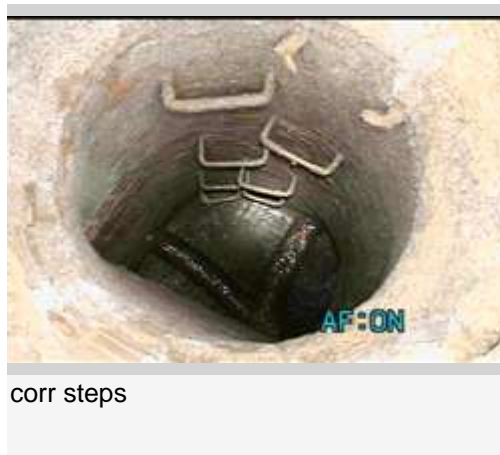
Defect 2

Count: **8** Missing: **1** ☒ **Corroded**

corr steps

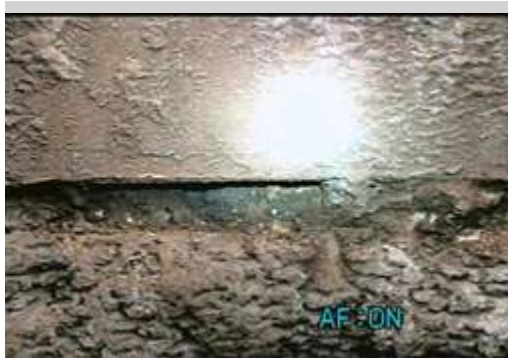
Defect 1

☒ **Leaks**

Condition: ☐ Sound ☐ Cracked ☐ Root Intrusion ☐ Loose Brick ☒ **Deteriorated**

Infiltration: ☐ None ☒ **Joint** ☐ Cracks ☐ Mortar ☐ Roots ☐ Wall

Chimney Deteriorated, Chimney and Frame Infiltration
